Cyclone Phailin in Odisha

October 2013

Rapid Damage and Needs Assessment Report

December 2013

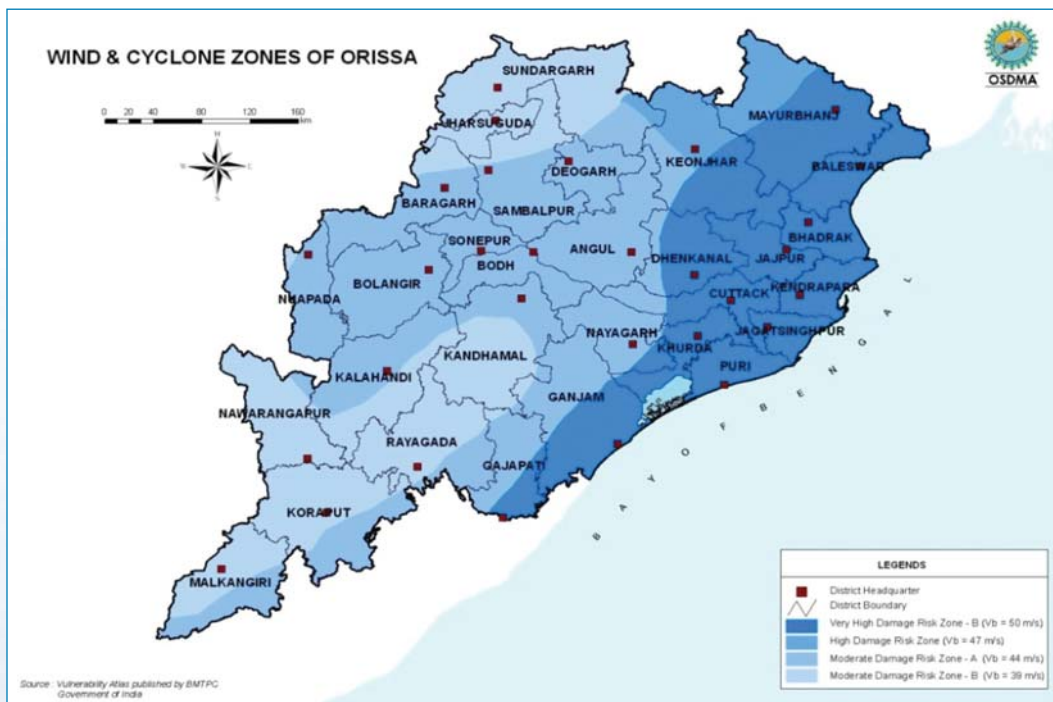
Figure 1: Wind and Cyclone Zones of Odisha

5. In addition, while a large part of the state comes under Earthquake Risk Zone-II (Low Damage Risk Zone), the Brahmani Mahanadi graben and their deltaic areas come

under Earthquake Risk Zone-III (Moderate Damage Risk Zone) and this covers 43 out of the 103 Urban Local Bodies in the state. Furthermore, the state is also vulnerable to flash floods and landslides.
