Uttarakhand Disaster

June 2013

Rapid Damage and Needs

Assessment Report

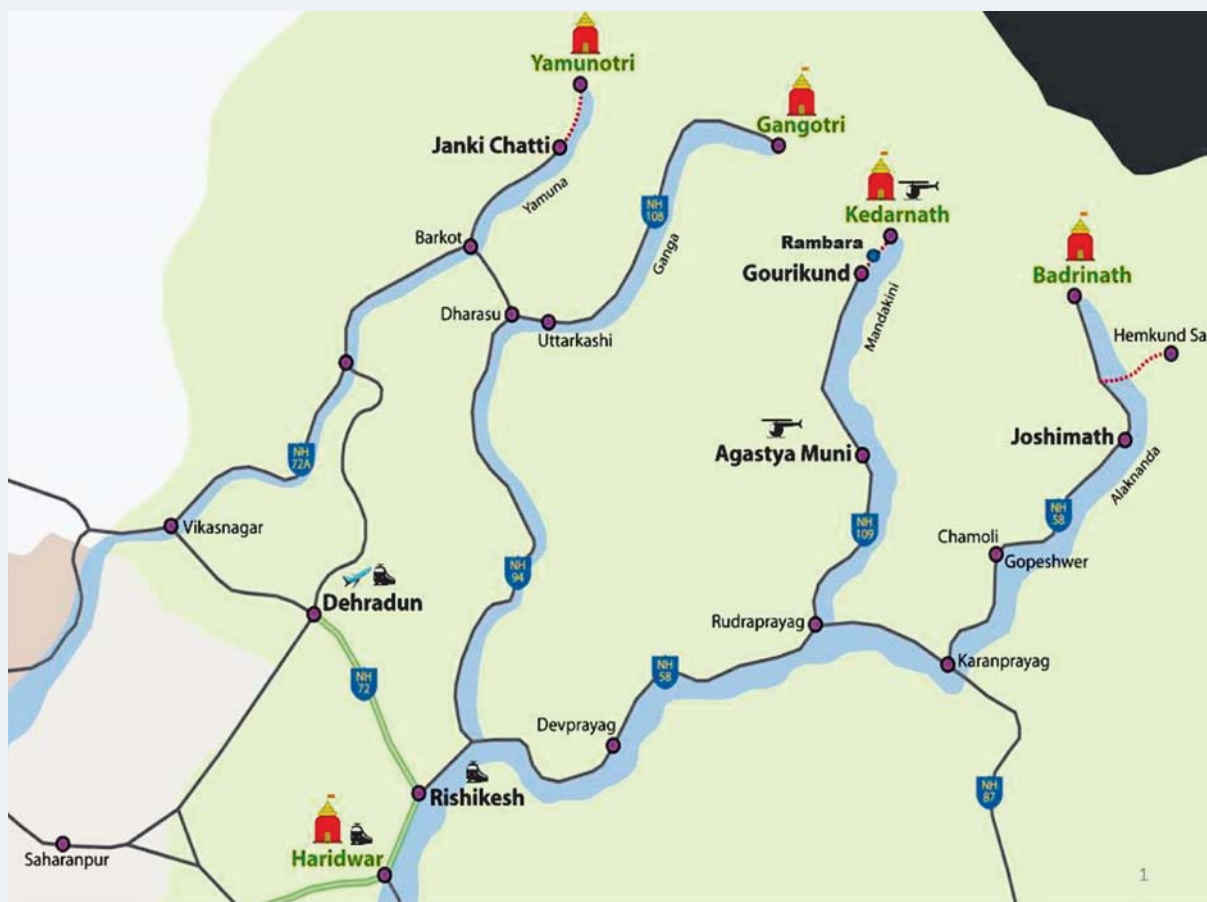
Figure 2 : Important Pilgrimage Centres "Char-Dham"

Bhagirathi and other river basins and also caused extensive river bed and toe erosion, and landslides at various locations. The worst impact happened in the Mandakini river valley around the Kedarnath shrine region (Rudraprayag district) and its downstream areas. Rock falls resulted in the partial blockade and impoundment on the river channel to the left of Kedarnath. The embankment on the left bank of the channel soon gave way and the abandoned channel to the east of Kedarnath became active. Adding to this, continuous rains and melting of the Chorabari glacier⁹ (that feeds the Gandhi Sarovar Lake or Chorbari Lake) caused waters in the Chorabari Lake to rise. The lake's weak moraine barrier gave way and a huge volume of water along with large glacial boulders came down the channel to the east, devastating Kedarnath town, Rambara, Gaurikund and other places in its wake.
